Possible Carter Fuelling Nozzle Body Failures

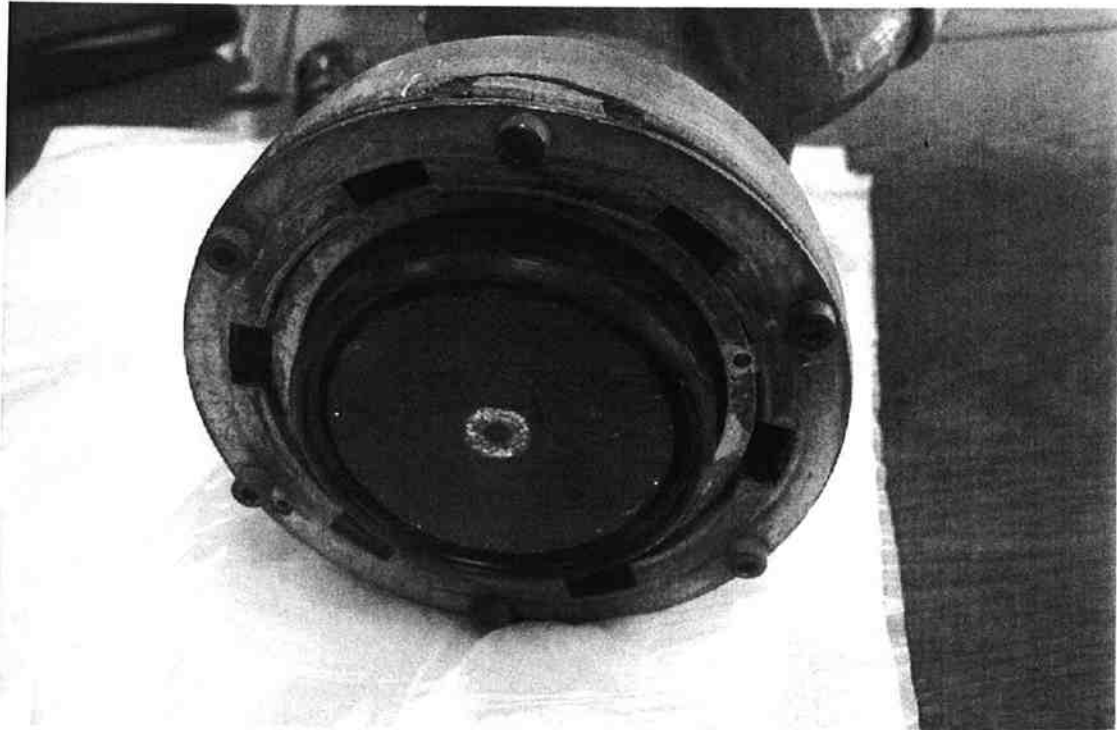
Some Carter model 64200 underwing pressure nozzles have been found damaged as shown in the photograph below. The damage was hidden by the red coloured bump ring.

An investigation has indicated that the failures may be related to a manufacturing defect and a Service Bulletin has now been prepared by Carter and is available on www.argo-tech.com. This Service Bulletin, SB200061005 dated July 11 2005, recommends that 64200 nozzles with serial numbers in the range 831 to 1088 be removed from service for inspection.

The serial numbers of all 64200 nozzles (serial number is etched on nozzle body) should be checked as soon as possible and any with serial numbers within the range 831 to 1088 should be removed from service and returned to the supplier for a free of charge replacement. The replacement will be for the basic nozzle only. Options such as HEPCV, swivels or handles should not be returned. Details of the returns including serial numbers, date returned and supplier/distributor name should be notified to kdeibler@argo-tech.com.
